**The Pepper Building
Terra Cotta/Masonry Façade Review
Evaluation and Recommendations**

JANUARY 23, 2004

I. INTRODUCTION

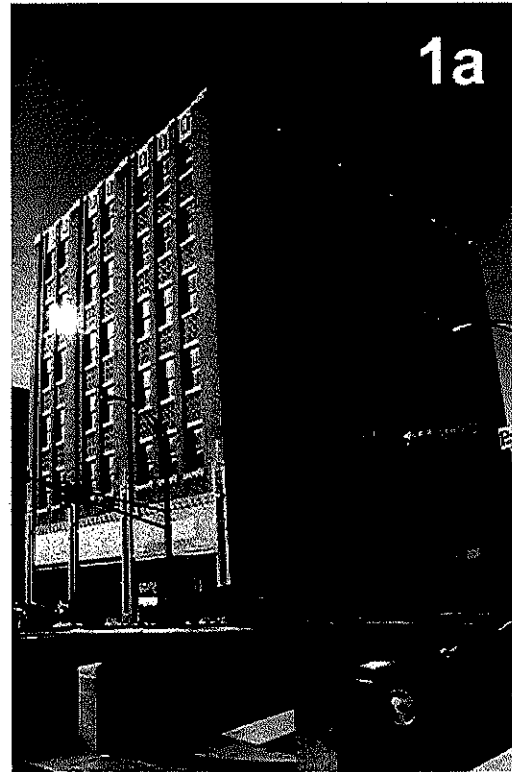
Photo 1a: Overview of the structure's two primary elevations.

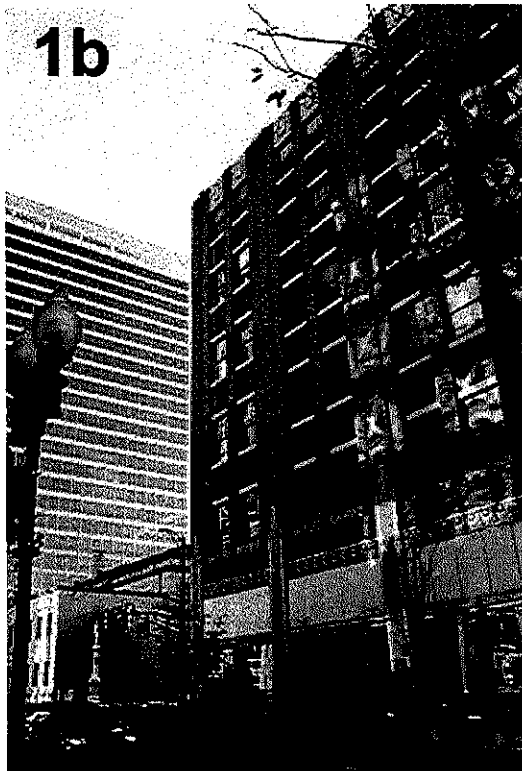
Photo 1b: Partial north elevation, which was the site (northeastern corner bay) of the hands-on inspection conducted on this elevation.

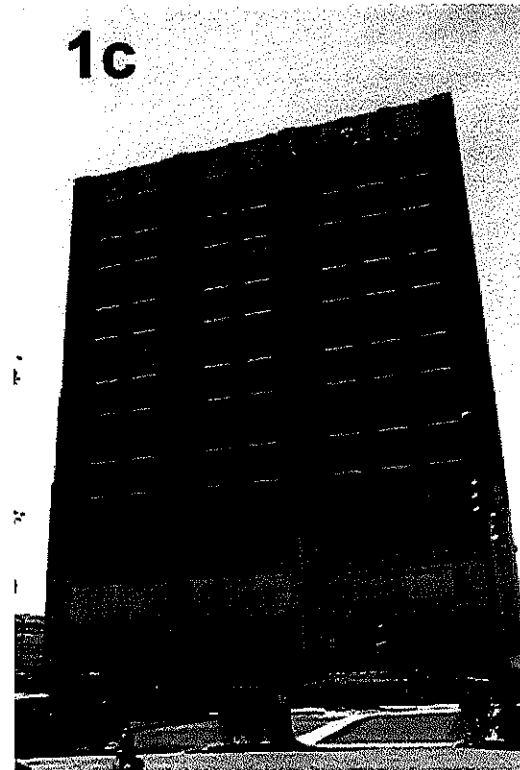
Photo 1c: East elevation showing the site of the second hands-on inspection.

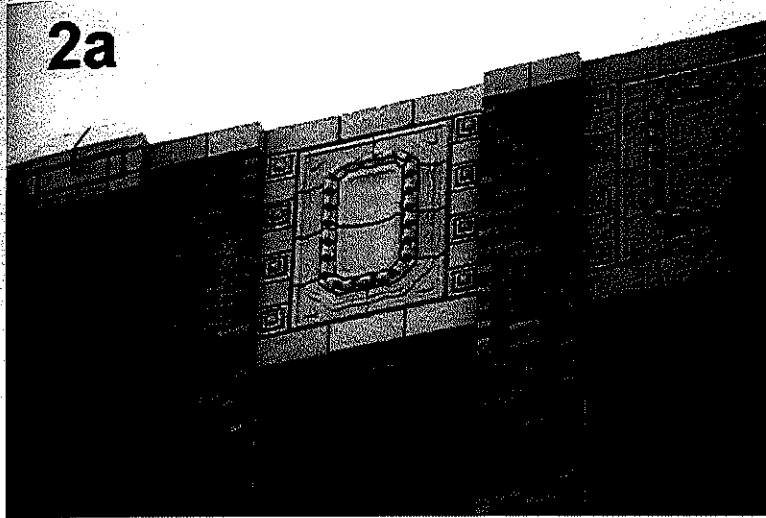
Photo 2a: Close-up view of the sixth floor window spandrel terra cotta assembly, which is an extension of the typical window lintel, cover trim (typically detailed over the entire structure). These spandrel assemblies also blend into the coping/pier cap assembly.

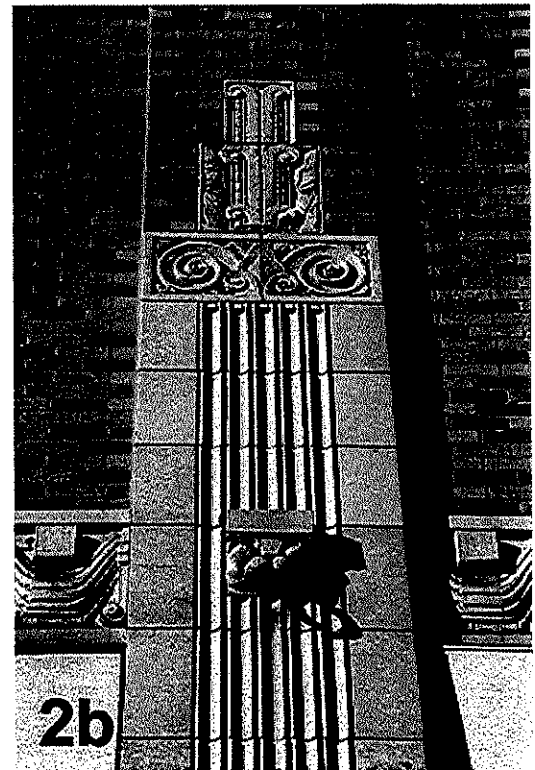
Photo 2b: Termination detail of 1st floor column cover assemblies, which are embellished with classical order Greek detailing.

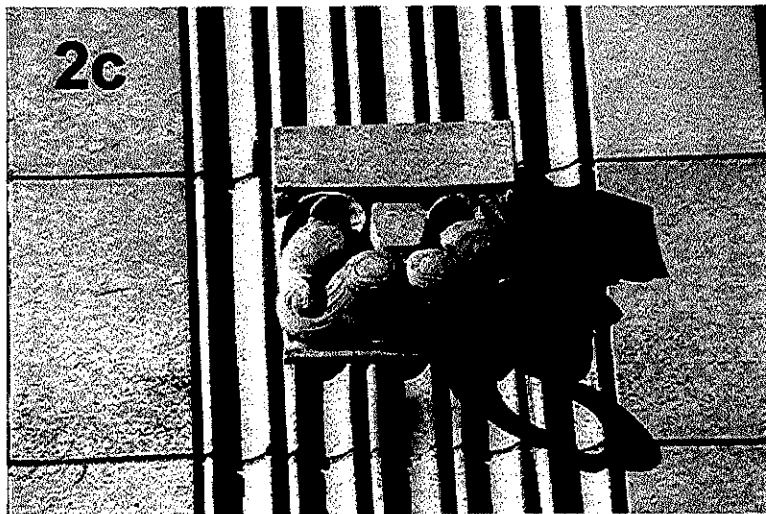
Photo 2c: Integral supports for the original canopies were incorporated within the terra cotta assembly.

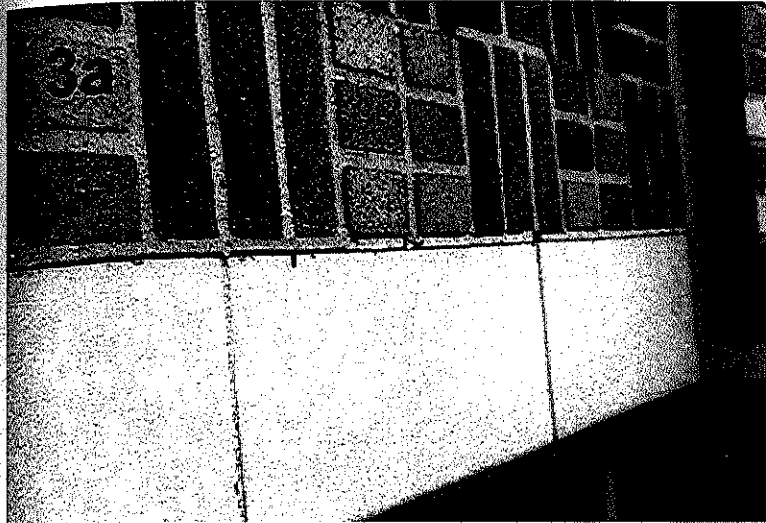
- Photo 3a:** On both primary building elevations, a 3-piece terra cotta assembly serves as the window head and is suspended from a steel lintel, which frames the window opening. At all locations viewed, (85 total on the project) displacement caused by the hidden framing lintel was evident in varying degrees. This photograph shows a north elevation site exhibiting the minimum displacement observed.

On the two primary elevations, 85 double hung windows located on floors two through six share common detailing as identified previously in photo series #3 and probe site one (1). All of these sites exhibit varying levels of advanced deterioration, which if left unaddressed, will fail. Along with the failure of the terra cotta cladding, the deteriorative mechanism identified (corrosion of the exterior window frame lintel located directly above the terra cotta) also causes distress within adjacent components. Façade components that are compromised because of the lintel corrosion include: 1) the terra cotta lintel cladding; 2) the window frames below the lintel; 3) the masonry clad piers in which the lintel bears; 4) the decorative brick masonry spandrel panels located above the lintel floors two (2) through five (5) of which it supports; and 5) the sixth floor terra cotta spandrel/parapet assembly.

- A. Access and stabilize brick or terra cotta spandrels located above the lintel assemblies.
- B. Remove the terra cotta lintel covers.
- C. Remove the steel lintel (exterior) including its bearing areas which extend outward into the adjacent brick column covers or piers.
- D. Design and install a new lintel to support the masonry above and accommodate the replacement terra cotta materials meeting applicable codes. Also include proper flashing for protection.
- E. Replace the original terra cotta with either precast concrete coated to approximate the original glaze finish, glass fiber reinforced concrete (GFRC) or new terra cotta.
- F. Repair the adjacent brick masonry removed to access the lintel, toothing out brick units and matching the original configuration.
- G. Stabilize and repair the spandrel material above the new lintel, either basket weave brick or terra cotta.

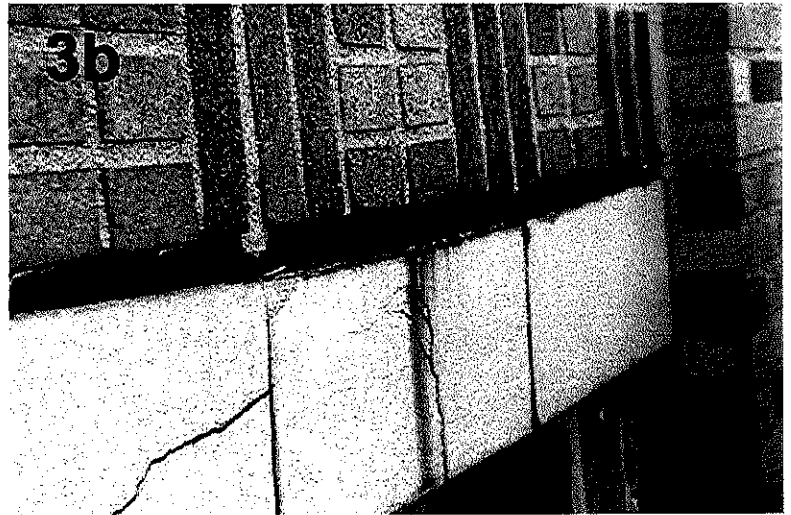
- Photo 3b:** Severe corrosion and resulting oxide jacking at a north elevation window lintel assembly.
- Photo 3c:** North elevation oxide jacking at lintels where the adjoining brick pier is also displaced, cracked and bowed outward. Also note that the terra cotta has rotated outward and that while difficult to discern from this photo, horizontal cracking within the brick spandrel above was also noted.

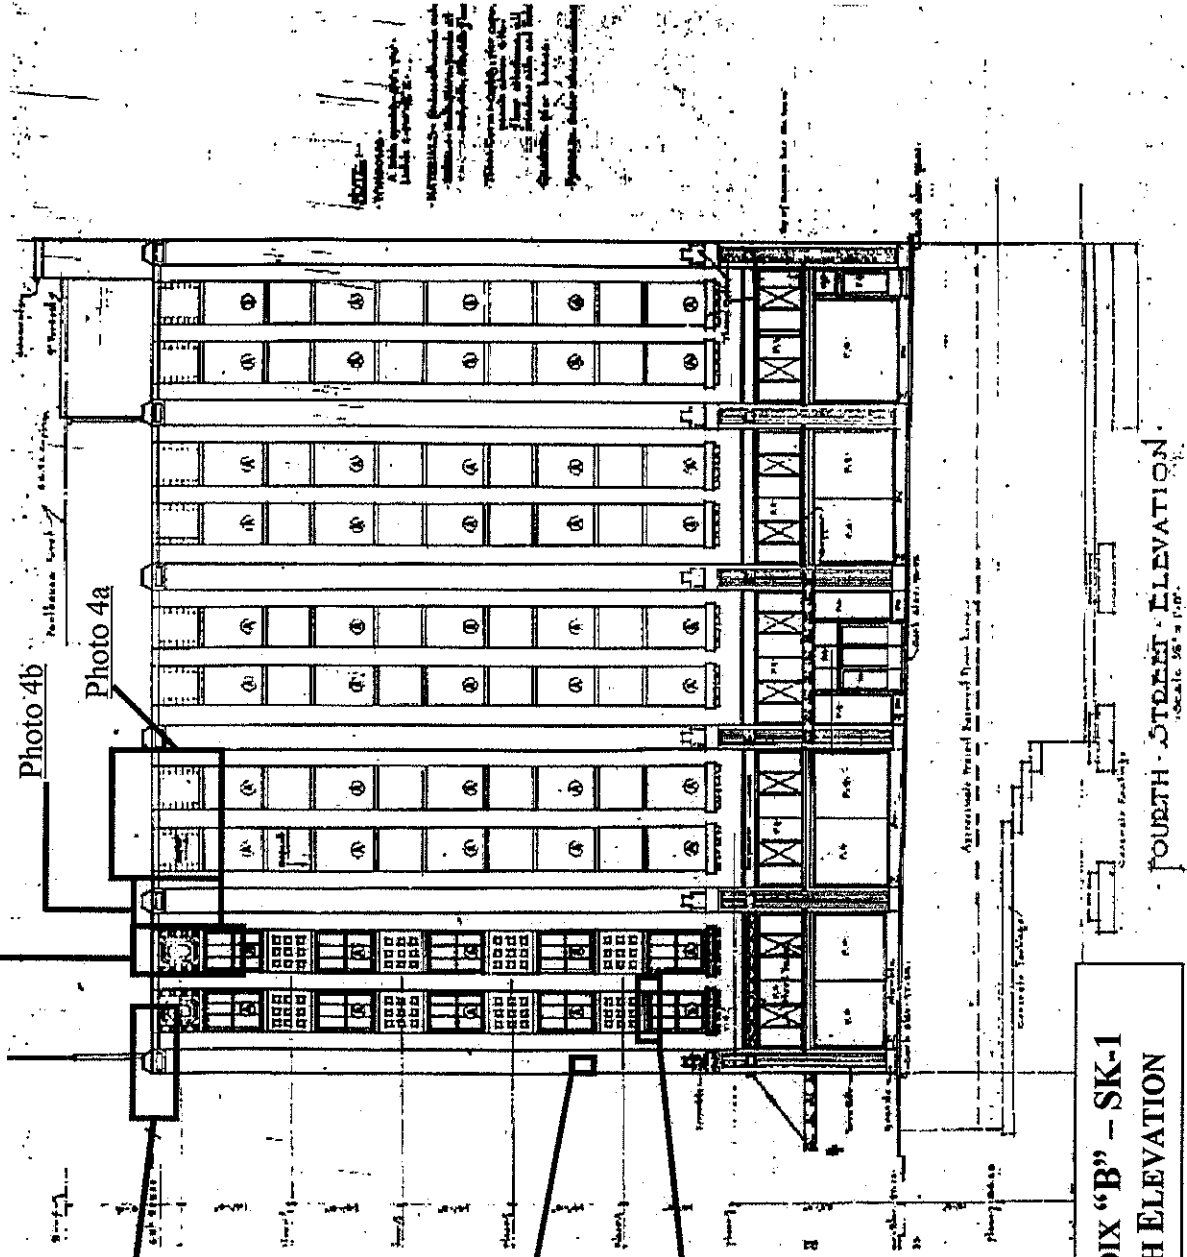
APPENDIX "B" - SK-1
 NORTH ELEVATION

- Photo 4a:** Horizontal cracking is evident through the terra cotta spandrels and adjacent brick piers. Also visible is the inward rotation of the entire parapet assembly. This phenomenon (parapet dumping) is caused by oxide jacking of various internal steel supports. See Appendix B, SK-1 for general location.
- Photo 4b:** Vertical and horizontal displacement of a masonry pier cap assembly, see Appendix B, SK-1 for location.
- Photos 4c/d:** Overview and close-up respectively of terra cotta spandrel, brick pier and coping/pier cap displacement. See Appendix B, SK-1 for location.

- Photo 5a:** Condition of a window lintel cover exhibiting cracking and incipient spalls. Also note the horizontal crack contained within the decorative brick spandrel above (See Appendix B, SK-1 for probe and photo location).

- Photo 6a:** Condition of a 6th floor terra cotta spandrel exhibiting cracking, incipient spalls, previous cementitious patch sites and displacement with cracking of adjacent brick piers (See Appendix B, SK-1 for probe and photo location).
- Photo 6b:** The terra cotta was removed by hand along with an adjacent brick. Corrosion of a 12" I-beam was identified as the cause for the cracking.
- Photo 6c:** Corrosion buildup by-product, located on the beam's web full height.
- Photo 6d:** Where the terra cotta components were slotted to interface and bear onto the projecting beams bottom flange, corrosion by-product (oxide jacking) was identified as the cause of the cracking.
- Photo 6e:** The adjacent brick pier cracking occurs at the same elevation as the beams upper flange projection.

Photo 7a: Vertical cracking located at the north elevation of the buildings northeast corner (See Appendix B, SK-1 for probe and photo location).

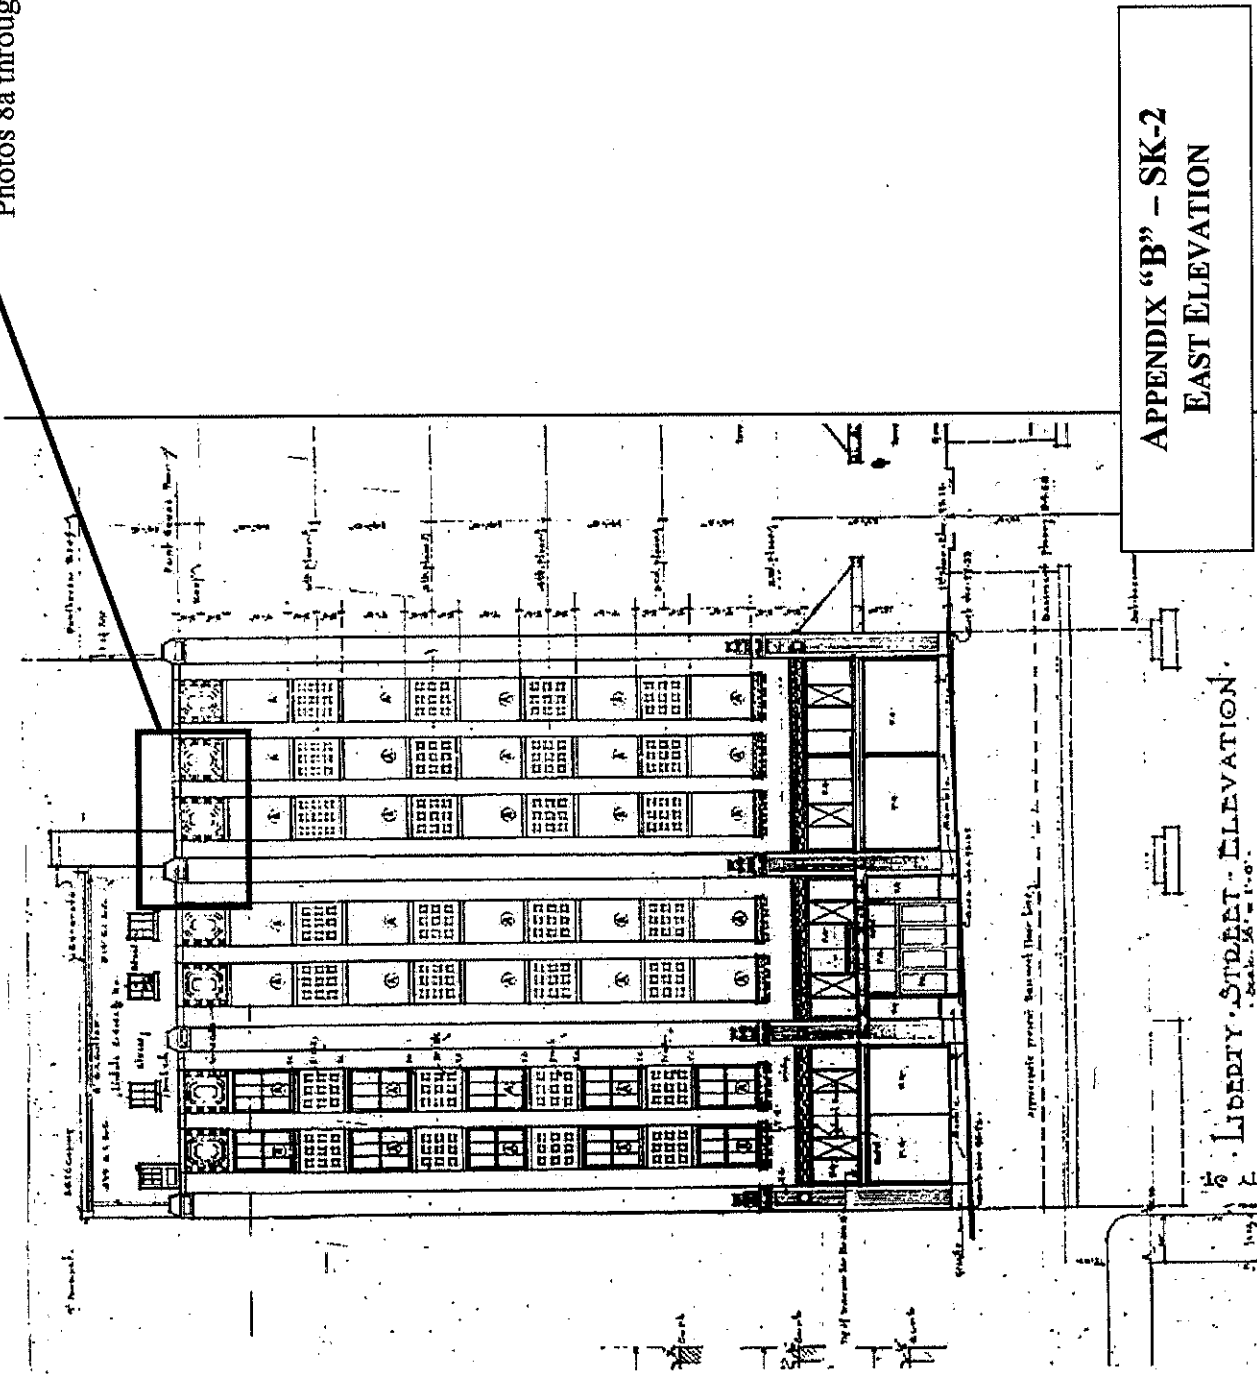
APPENDIX "B" - SK-2
 EAST ELEVATION

Photo 8a: Spandrel panel, terra cotta coping and pier cap assembly located on the east elevation. Only minimal brick cracking and no discernable dumping of the east elevation parapet was evident including little or no terra cotta spandrel component cracking (See Appendix B, SK-2 for probe and photo location).
