**The Pepper Building
Terra Cotta/Masonry Façade Review
Evaluation and Recommendations**

JANUARY 23, 2004

I. INTRODUCTION

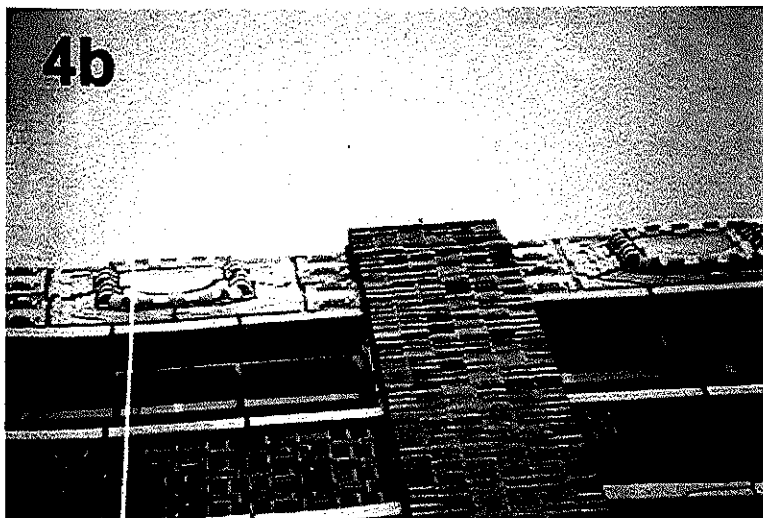
- Photo 4a:** Horizontal cracking is evident through the terra cotta spandrels and adjacent brick piers. Also visible is the inward rotation of the entire parapet assembly. This phenomenon (parapet dumping) is caused by oxide jacking of various internal steel supports. See Appendix B, SK-1 for general location.
- Photo 4b:** Vertical and horizontal displacement of a masonry pier cap assembly, see Appendix B, SK-1 for location.
- Photos 4c/d:** Overview and close-up respectively of terra cotta spandrel, brick pier and coping/pier cap displacement. See Appendix B, SK-1 for location.
